### Service manual

# VRV IV+ Heat Pump

RYYQ8U RYMQ14U RYYQ10U RYMQ16U RYYQ12U RYMQ18U RYYQ14U RYMQ20U RYYQ16U RYYQ18U RXYQ8U RYYQ20U RXYQ10U RXYQ12U RYMQ8U RXYQ14U RYMQ10U RXYQ16U

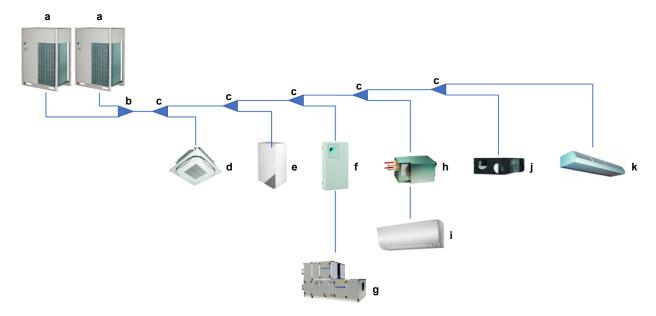
The below illustration does not reflect allowed combinations or compatibility. The intention is to give an overview on piping installation for different types of units.

- a VRV IV+ HP outdoor unit
- Refnet BHFQ22P for Outdoor multi connection
- c Refnet KHRQ22M
- d VRV indoor unit
- e Low temperature Hydrobox<sup>(a)</sup>
- f Expansion valve kit

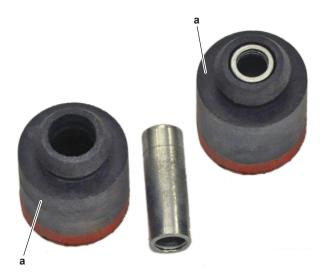
- **2** Visually check:
  - For oil drops around the compressor. Locate and fix as needed.
  - Pipes for signs of damage. Replace pipes as needed.
- **3** Check that the compressor bolts are correctly fixed. Fix as needed.
- 4 Check that the compressor wire terminals cover is correctly installed and fixed. Correct as needed.
- **5** Check the compressor dampers for any damage.

## **a** Damper

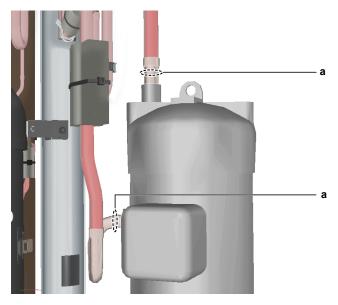
a Compressor pipe

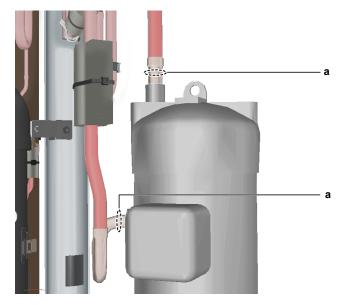
a Compressor pipe

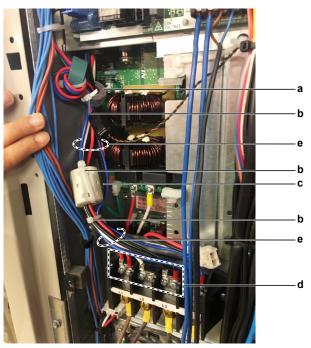
**2** Disconnect the current sensor connector from the main PCB.

- a Current sensor
- **b** Tie wrap
- **c** Ferrite core
- **d** Screw connections
- **e** Power wiring
- **3** Remove the necessary tie wraps from the wiring of the current sensor and the power wiring.
- **4** Remove the ferrite core.
- **5** Loosen the screw connections to disconnect the power wiring.
- **6** Slide the current sensor on the power wiring and remove the current sensor.

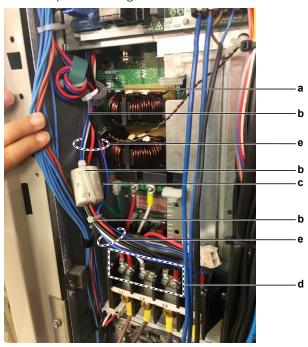
- 1 Slide the current sensor on the power wiring and install the current sensor in place.
- 2 Install the power wiring in the connections and fasten the screws.

- Current sensor
- Tie wrap
- **c** Ferrite core
- **d** Screw connections
- e Power wiring
- **3** Connect the current sensor connector.
- Install the ferrite core.
- Install new tie wraps on the wiring of the current sensor and on the power wiring.

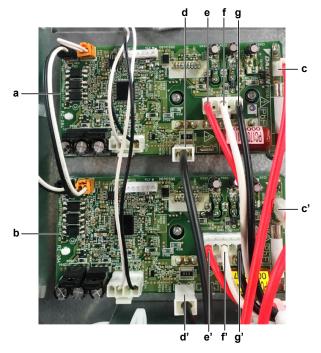
- **a** Fan inverter PCB A4P
- **b** Fan inverter PCB A5P or A7P
- c/c' Connector P11
- **d / d'** Connector N11
- e / e' Connector X1A, pin U
- **f/f'** Connector X1A, pin V
- g/g' Connector X1A, pin W

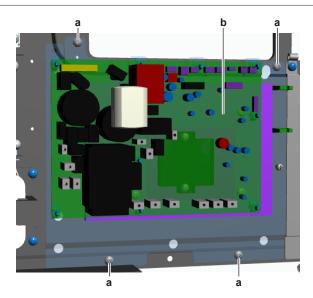
- **a** Screw
- Inverter PCB
- 2 Remove all wiring from the inverter PCB mounting plate (harness retainers, tie straps).
- **3** Remove the inverter PCB mounting plate (with inverter PCB mounted).
- To install the new inverter PCB, see "3.8.2 Repair procedures" [> 238].
- INVERTER PCB A6P

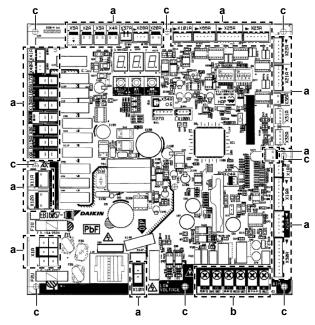
- a Cable clamp
- **2** Disconnect all connectors from the main PCB assembly.

- Connector
- Wire terminal
- c PCB support
- **3** Note the field wiring on X1M transmission field wiring terminals.
- **4** Disconnect wiring connections on wiring terminals.
- **5** Carefully pull the PCB at the side and unlatch the PCB supports one by one using a small pair of pliers.
- Remove the main PCB.
- To install the new outdoor unit main PCB, see "3.9.2 Repair procedures" [▶ 247].

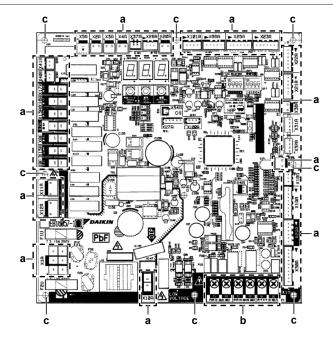
- **a** Connector
- **b** Wire terminal
- c PCB support
- **3** Connect all connectors to the main PCB assembly.

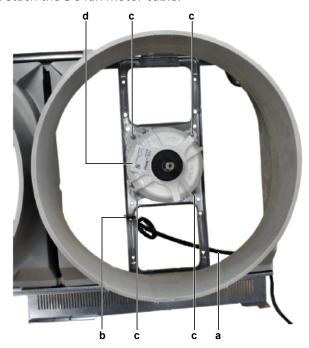
- Disconnect the DC fan motor connector.
- Cut the tie strap.
- Detach the DC fan motor cable.

- Fan motor cable
- Tie wrap
- Screw
- Fan motor
- **5** Remove the 4 screws that fix the DC fan motor assembly.
- Remove the DC fan motor assembly from the unit.
- 7 To install the DC fan motor assembly, see "Repair procedures" [▶ 265].

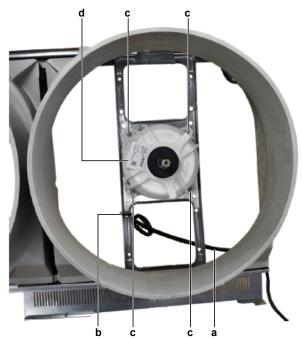
- Remove the propeller fan blade assembly from the DC fan motor assembly, see "Repair procedures" [▶ 269].
- 2 Remove the required plate work, see "3.13 Plate work" [> 271].
- **3** Disconnect the DC fan motor connector.
- Cut the tie strap.
- Detach the DC fan motor cable.

- Fan motor cable
- Tie wrap
- Screw
- **d** Fan motor
- Remove the 4 screws that fix the DC fan motor assembly.
- Remove the DC fan motor assembly from the unit.

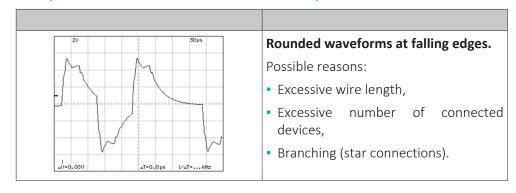
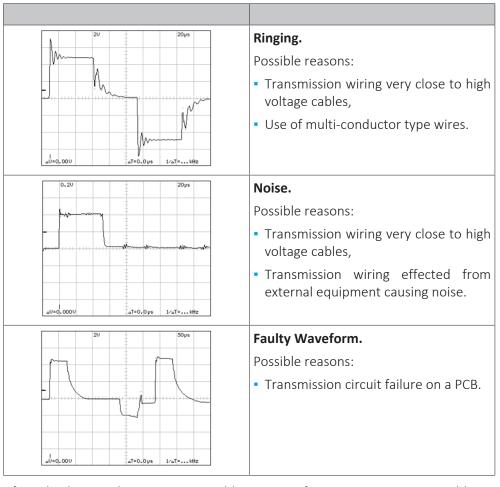
# **Examples of waveform distortions on D3Net and possible causes:**

After checking and correcting possible causes of F1-F2 transmission problems, perform a communication reset (see "4.1.2 Repair procedures" [▶ 311]).

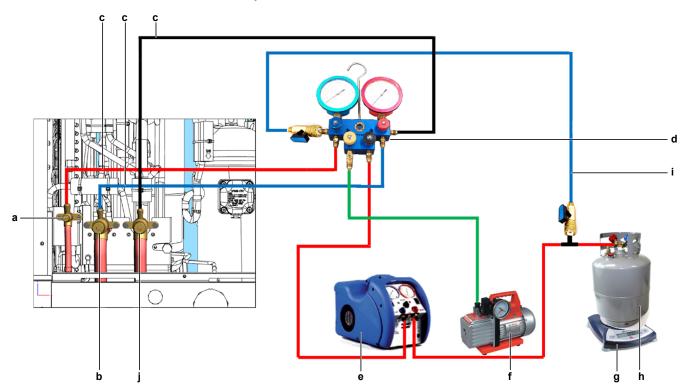
# For RYMQ-U units

- a Liquid service port
- **b** Gas service port
- **c** Flexible hose
- **d** Manifold
- **e** Recovery unit
- f Vacuum pump
- **g** Scale
- **h** Recovery cylinder
- i Vacuum setup
- **j** Equalizing pipe service port

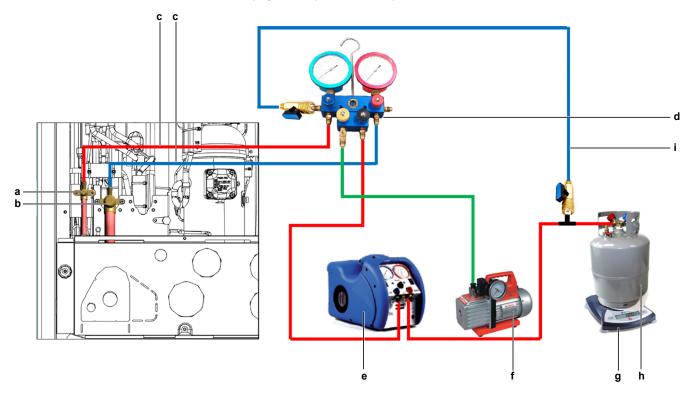
#### For RXYQ-U, RXYTQ-U and RYYQ-U units

- a Liquid service port
- **b** Gas service port
- **c** Flexible hose
- **d** Manifold
- e Recovery unit
- f Vacuum pump
- **g** Scale
- h Recovery cylinder
- i Vacuum setup
- **4** Activate refrigerant recovery / vacuum mode by setting field setting mode 2-21 to 1 (see "6.9 Field settings" [▶ 388]).

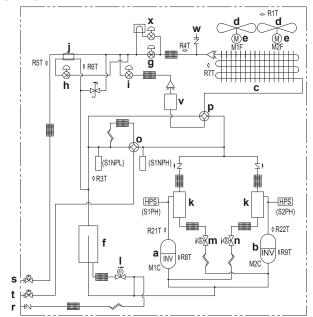
#### Piping diagram: RYYQ14~20

- a Compressor (M1C)
- **b** Compressor (M2C)
- c Heat exchanger
- **d** Far
- e Fan motor (M1F, M2F)
- **f** Accumulator
- g Expansion valve, main (Y1E)
- **h** Expansion valve, subcool heat exchanger (Y2E)
- i Expansion valve, storage vessel (Y4E)
- j Subcool heat exchanger
- **k** Oil separator
- Solenoid valve, oil accumulator (Y2S)

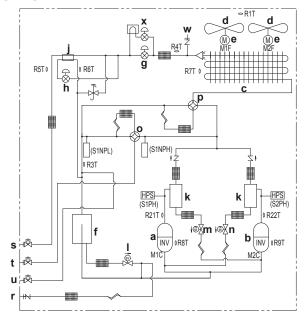
#### Piping diagram: RYMQ14~20

- a Compressor (M1C)
- **b** Compressor (M2C)
- c Heat exchanger
- **d** Fan
- e Fan motor (M1F, M2F)
- **f** Accumulator
- g Expansion valve, main (Y1E)
- **h** Expansion valve, subcool heat exchanger (Y2E)
- i Expansion valve, storage vessel (Y4E)
- j Subcool heat exchanger
- **k** Oil separator
- I Solenoid valve, oil accumulator (Y2S)

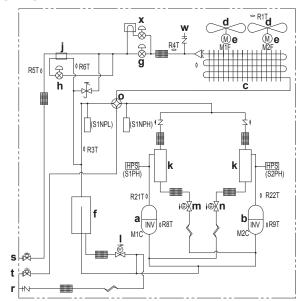
#### Piping diagram: RXYQ14~20

- a Compressor (M1C)
- **b** Compressor (M2C)
- c Heat exchanger
- **d** Fan
- e Fan motor (M1F, M2F)
- **f** Accumulator
- g Expansion valve, main (Y1E)
- **h** Expansion valve, subcool heat exchanger (Y2E)
- i Expansion valve, storage vessel (Y4E)
- **j** Subcool heat exchanger
- **k** Oil separator
- I Solenoid valve, oil accumulator (Y2S)

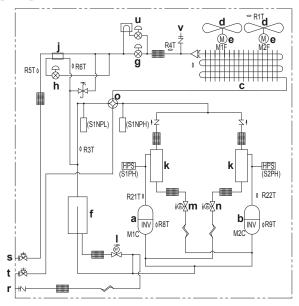
#### Piping diagram: RXYTQ14+16

- Compressor (M1C)
- b Compressor (M2C)
- Heat exchanger
- Fan d
- Fan motor (M1F, M2F)
- f Accumulator
- Expansion valve, main (Y1E)
- Expansion valve, subcool heat exchanger (Y2E)
- Expansion valve, storage vessel (Y4E)
- Subcool heat exchanger
- Oil separator
- Solenoid valve, oil accumulator (Y2S)
- Solenoid valve, oil1 (Y3S)
- Solenoid valve, oil2 (Y4S)
- o 4-way valve, main (Y1S)
- **p** 4-way valve, sub (Y5S)
- **q** Electrical component box
- r Service port, refrigerant charge
- **s** Stop valve, liquid
- t Stop valve, gas
- **u** Expansion valve, liquid cooling (Y3E)
- **v** Service port

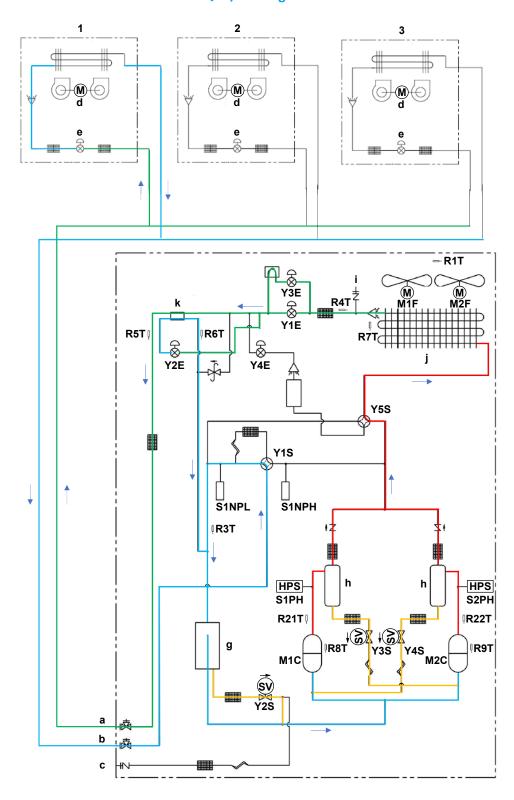
# RYYQ-U / Cooling mode

Indoor unit 1: Operation ON, Thermo ON, Fan ON, Expansion valve: normal control

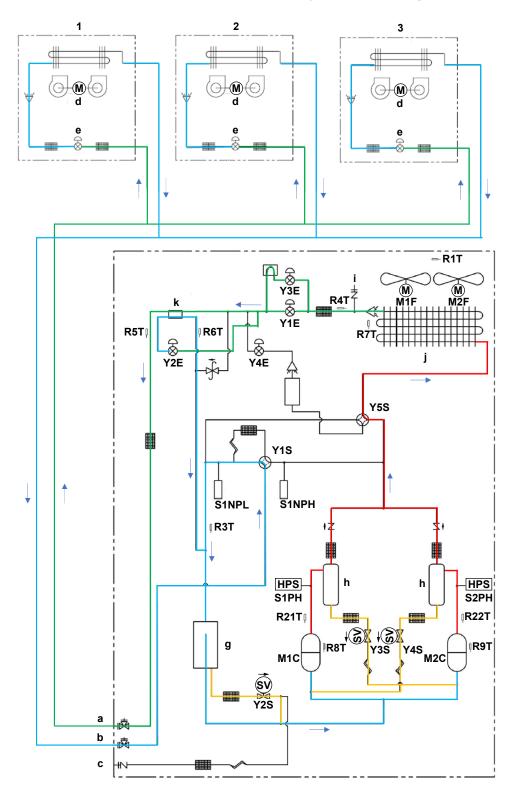
## RYYQ-U / Oil return operation in cooling mode

**Indoor unit 1:** Operation ON, Thermo ON, Fan ON, Expansion valve: normal control

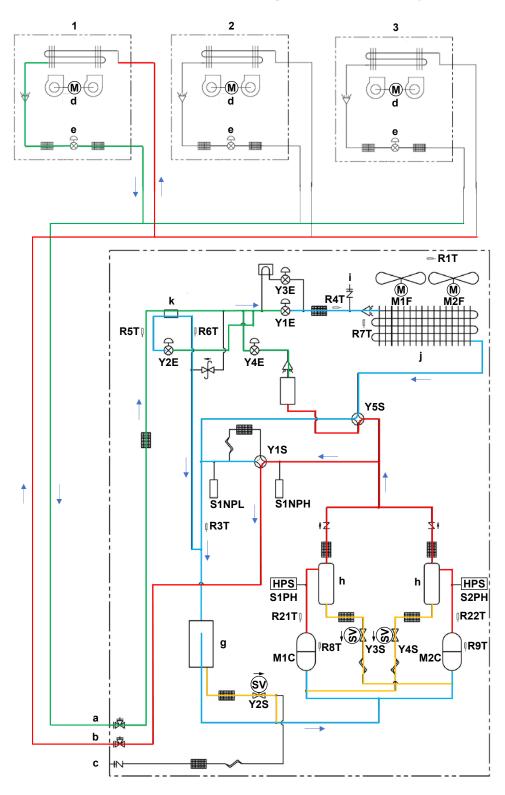
RYYQ-U / Heating mode and oil return operation in heating mode

Indoor unit 1: Operation ON, Thermo ON, Fan ON, Expansion valve: normal control **Indoor unit 2:** Operation OFF, Fan OFF, Expansion valve: average subcool control

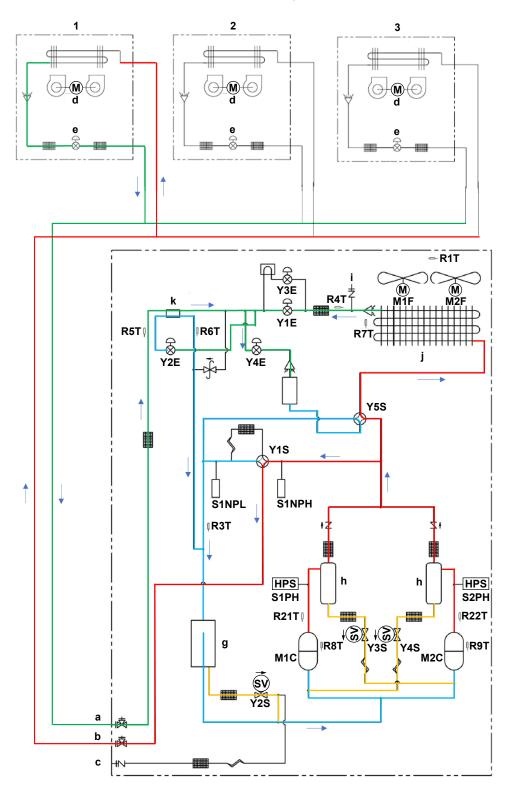
## **RYYQ-U / Defrost operation**

Indoor unit 1: Operation ON, Thermo ON, Fan ON, Expansion valve: normal control

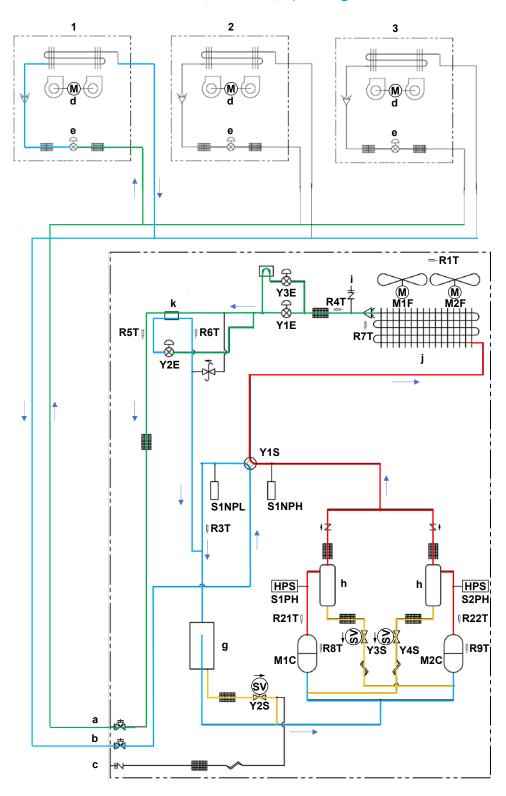
## RXYQ-U + RXYTQ-U / Cooling mode

Indoor unit 1: Operation ON, Thermo ON, Fan ON, Expansion valve: normal control

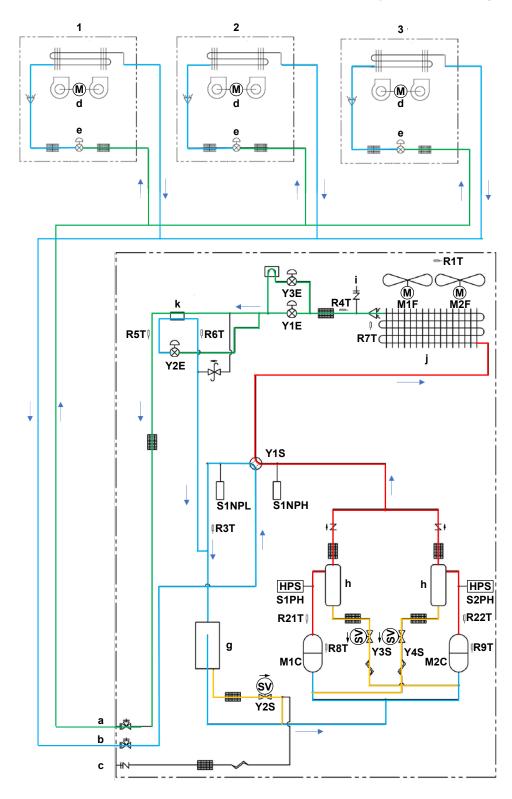
## RXYQ-U + RXYTQ-U / Oil return operation in cooling mode

Indoor unit 1: Operation ON, Thermo ON, Fan ON, Expansion valve: normal control

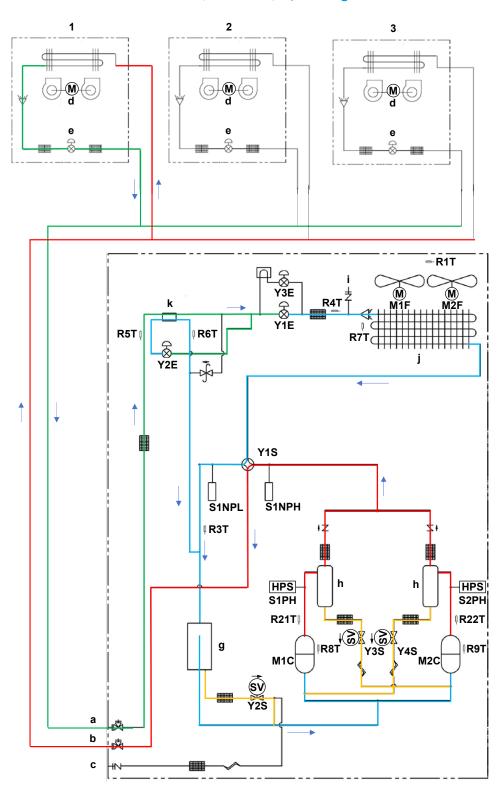
## RXYQ-U + RXYTQ-U / Heating mode

Indoor unit 1: Operation ON, Thermo ON, Fan ON, Expansion valve: normal control **Indoor unit 2:** Operation OFF, Fan OFF, Expansion valve: average subcool control

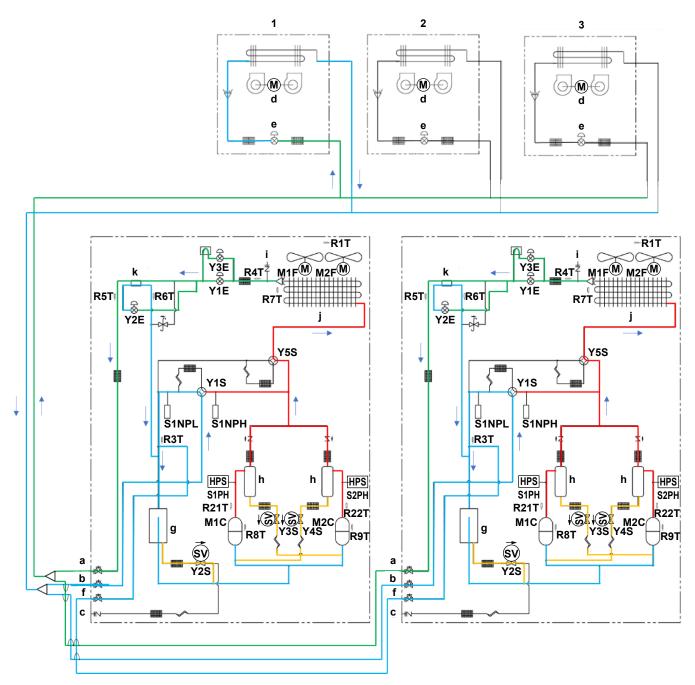
## **RYMQ-U / Cooling mode**

Indoor unit 1: Operation ON, Thermo ON, Fan ON, Expansion valve: normal control

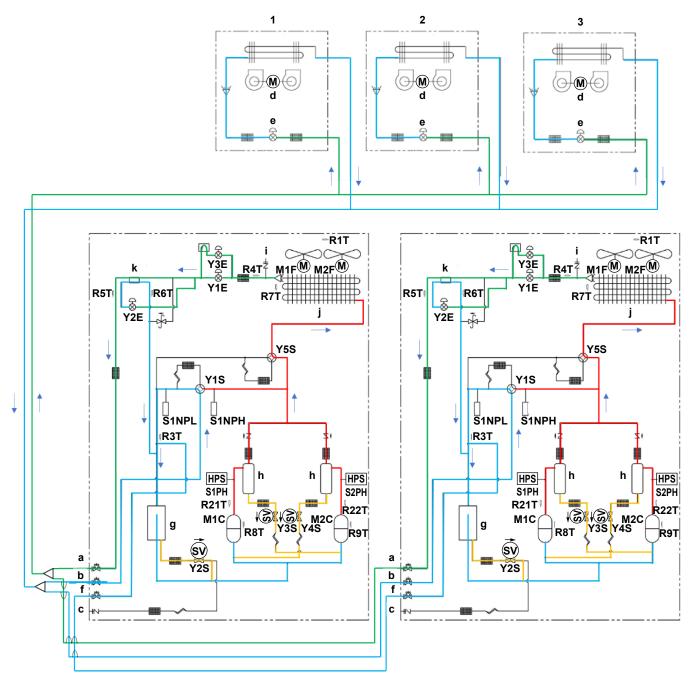
## RYMQ-U / Oil return operation in cooling mode

Indoor unit 1: Operation ON, Thermo ON, Fan ON, Expansion valve: normal control

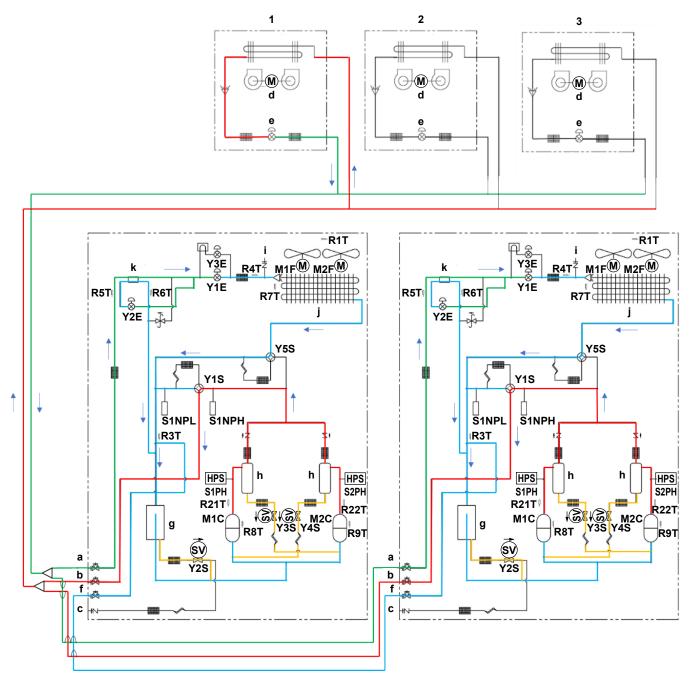
RYMQ-U / Heating mode and oil return in heating mode

Operation ON, Thermo ON, Fan ON, Expansion valve: normal control Operation OFF, Fan OFF, Expansion valve: average subcool ontrol Indoor unit 2: Indoor unit 3: Operation ON, Thermo OFF, Fan ON, average subcool control

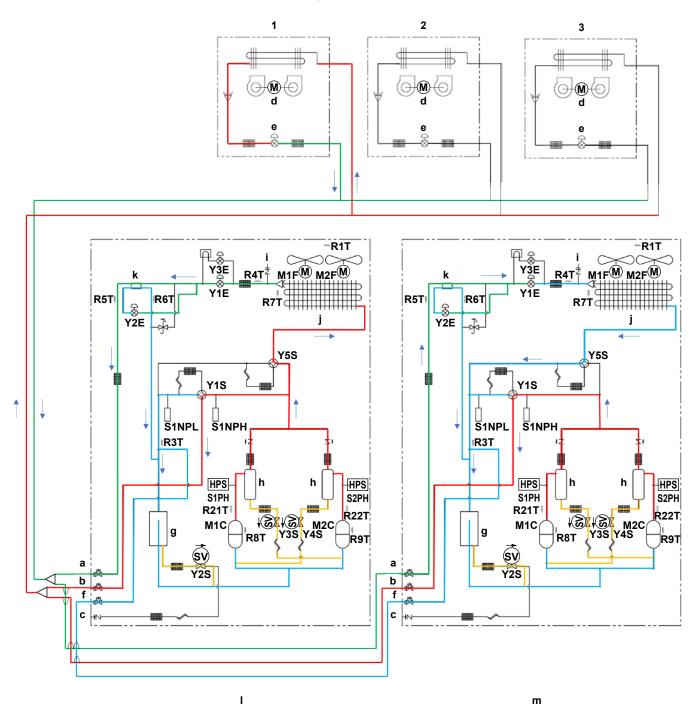
#### **RYMQ-U / Defrost operation**

Indoor unit 1: Operation ON, Thermo ON, Fan ON, Expansion valve: normal control

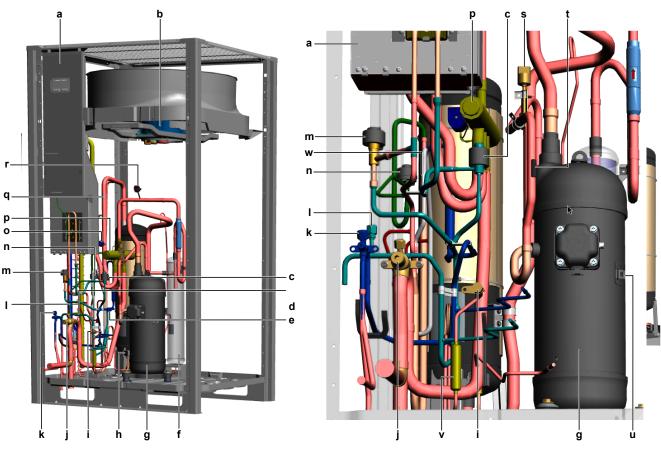
#### 6.4.1 Component overview: RXYQ8~12U + RXYTQ8U units

- a Switchbox, for details see "6.5 Switchbox overview" [▶ 381].
- **b** Fan motor
- c Liquid cooling expansion valve Y3E
- d Liquid pipe thermistor, outdoor heat exchanger R4T
- e Liquid pipe thermistor, sub-cool heat exchanger R5T
- f Oil separator
- g Compressor M1C
- h Oil return valve Y2S
- i Charge port
- **j** Gas stop valve
- k Liquid stop valve
- I Service port
- **m** Main expansion valve Y1E
- n Sub-cool expansion Valve Y2E
- Low pressure sensor S1NPL

- **p** 4-way valve Y1S
- **q** Accumulator inlet thermistor R3T
- r Refrigerant high pressure sensor S1NPH
- s High pressure switch S1PH
- t Compressor (M1C) discharge thermistor R21T
- u Compressor (M1C) body thermistor R8T
- **v** Filter
- w Gas pipe thermistor, sub-cool heat exchanger R6T
- x Liquid receiver
- **y** Heat exchanger
- **z** De-icer thermistor, outdoor heat exchanger R7T
- aa Filter
- **ab** Oil return valve Y3S
- ac Filter

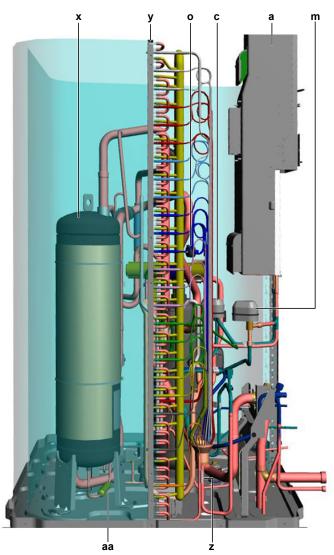
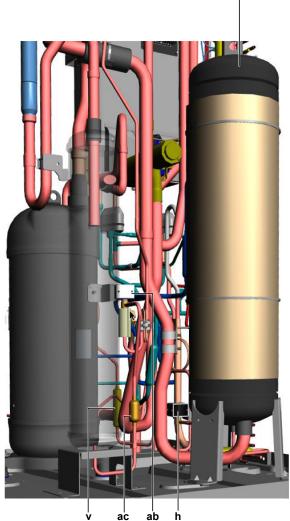
- Fan motor
- c Liquid cooling expansion valve Y3E
- **d** Liquid pipe thermistor, outdoor heat exchanger R4T
- e Liquid pipe thermistor, sub-cool heat exchanger R5T
- f Oil separator
- Compressor M1C
- h Oil return valve Y2S
- Charge port
- Gas stop valve
- k Liquid stop valve
- I Service port
- **m** Main expansion valve Y1E
- n Sub-cool expansion Valve Y2E
- Low pressure sensor S1NPL

**p** 4-way valve Y1S

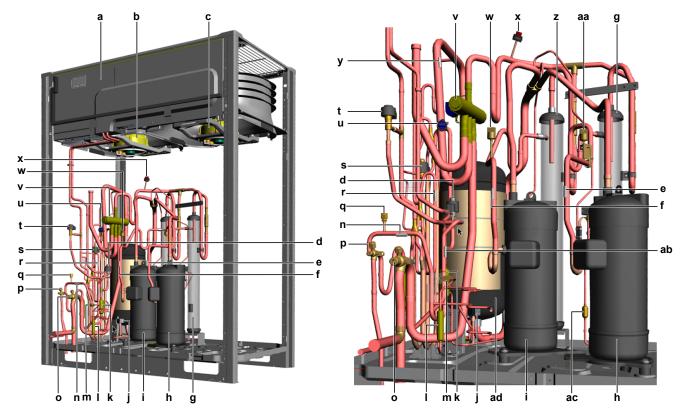
#### 6.4.2 Component overview: RXYQ14~16U + RXYTQ10~16U units

- a Switchbox, for details see "6.5 Switchbox overview" [▶ 381].
- **b** Fan motor M1F
- c Fan motor M2F
- d Liquid cooling expansion valve Y3E
- e Compressor (M1C) discharge thermistor R21T
- **f** Compressor (M2C) discharge thermistor R22T<sup>(1)</sup>
- **g** Oil separator
- h Compressor M1C + body thermistor R8T
- i Compressor M2C + body thermistor R9T<sup>(1)</sup>
- j Oil return valve Y2S
- **k** Filter
- I Filter
- **m** Charge port
- n Liquid pipe thermistor, outdoor heat exchanger R4T
- o Gas stop valve
- p Liquid stop valve
- **q** Service port
- r Gas pipe thermistor, sub-cool heat exchanger R6T

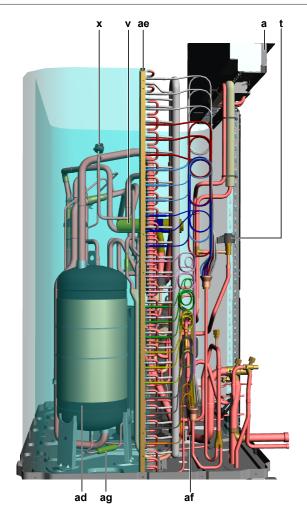
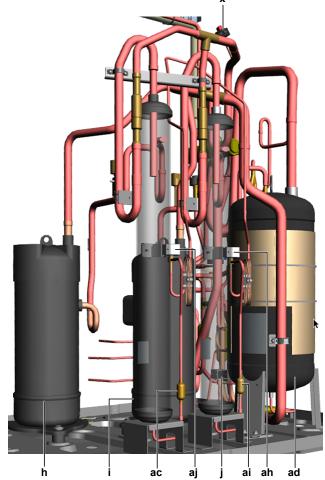
- a Switchbox, for details see "6.5 Switchbox overview" [> 381].
- Fan motor M1F
- c Fan motor M2F
- d Liquid cooling expansion valve Y3E
- e Compressor (M1C) discharge thermistor R21T
- **f** Compressor (M2C) discharge thermistor R22T<sup>(1)</sup>
- **h** Compressor M1C + body thermistor R8T
- Compressor M2C + body thermistor  $R9T^{(1)}$
- Oil return valve Y2S j
- Filter
- I Filter
- **m** Charge port
- **n** Liquid pipe thermistor, outdoor heat exchanger R4T
- o Gas stop valve
- **p** Liquid stop valve
- **q** Service port
- Gas pipe thermistor, sub-cool heat exchanger R6T

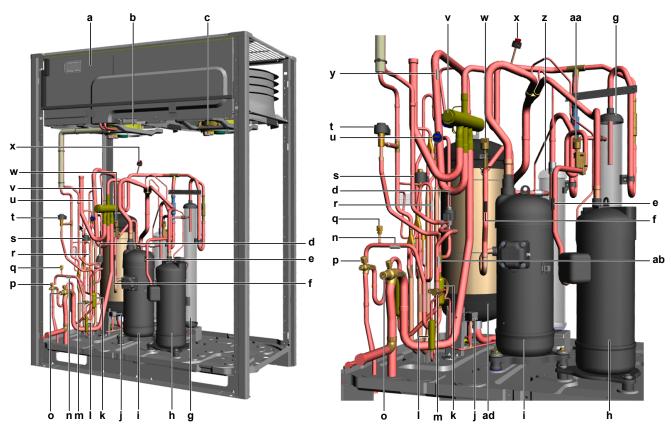
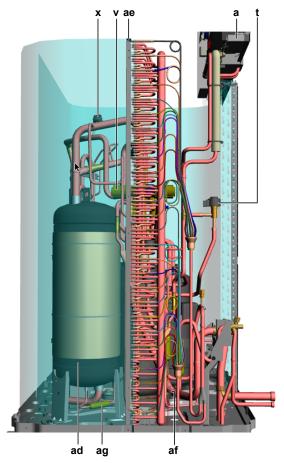
### 6.4.3 Component overview: RXYQ18~20U units

- a Switchbox, for details see "6.5 Switchbox overview" [▶ 381].
- **b** Fan motor M1F
- c Fan motor M2F
- d Liquid cooling expansion valve Y3E
- e Compressor (M1C) discharge thermistor R21T
- f Compressor (M2C) discharge thermistor R22T
- **g** Oil separator
- **h** Compressor M1C + body thermistor R8T
- i Compressor M2C + body thermistor R9T
- j Oil return valve Y2S
- **k** Filter
- **I** Filter
- **m** Charge port
- n Liquid pipe thermistor, outdoor heat exchanger R4T
- o Gas stop valve
- **p** Liquid stop valve
- **q** Service port
- r Gas pipe thermistor, sub-cool heat exchanger R6T

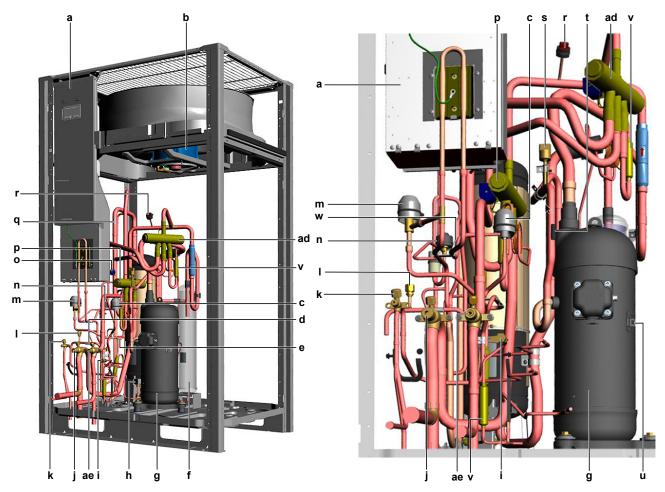
### 6.4.4 Component overview: RYMQ8~12U units

- a Switchbox, for details see "6.5 Switchbox overview" [▶ 381].
- **b** Fan motor
- c Liquid cooling expansion valve Y3E
- d Liquid pipe thermistor, outdoor heat exchanger R4T
- e Liquid pipe thermistor, sub-cool heat exchanger R5T
- f Oil separator
- **g** Compressor M1C
- **h** Oil return valve Y2S
- i Charge port
- **j** Gas stop valve
- **k** Liquid stop valve
- I Service port
- **m** Main expansion valve Y1E
- n Sub-cool expansion Valve Y2E
- Low pressure sensor S1NPL
- **p** 4-way valve Y1S

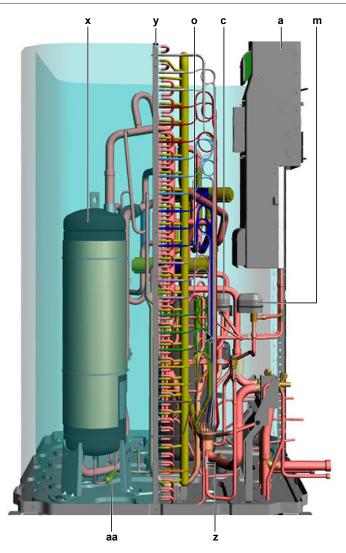
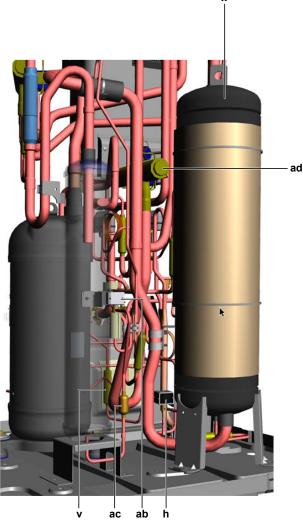
- Fan motor
- c Liquid cooling expansion valve Y3E
- **d** Liquid pipe thermistor, outdoor heat exchanger R4T
- e Liquid pipe thermistor, sub-cool heat exchanger R5T
- f Oil separator
- **g** Compressor M1C
- h Oil return valve Y2S
- i Charge port
- Gas stop valve j
- **k** Liquid stop valve
- I Service port
- m Main expansion valve Y1E
- n Sub-cool expansion Valve Y2E
- o Low pressure sensor S1NPL
- **p** 4-way valve Y1S

- **q** Accumulator inlet thermistor R3T
- Refrigerant high pressure sensor S1NPH
- High pressure switch S1PH
- Compressor (M1C) discharge thermistor R21T
- Compressor (M1C) body thermistor R8T u
- Gas pipe thermistor, sub-cool heat exchanger R6T w
- Liquid receiver Х
- Heat exchanger
- De-icer thermistor, outdoor heat exchanger R7T Z
- aa Filter
- Oil return valve Y3S ab
- ac Filter
- **ad** 4-way valve Y5S
- ae Equalising pipe

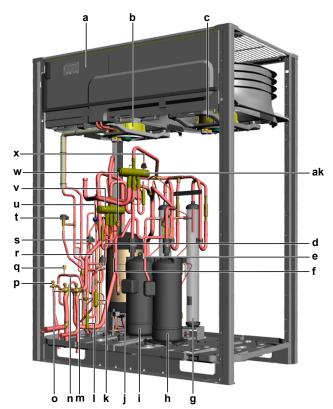
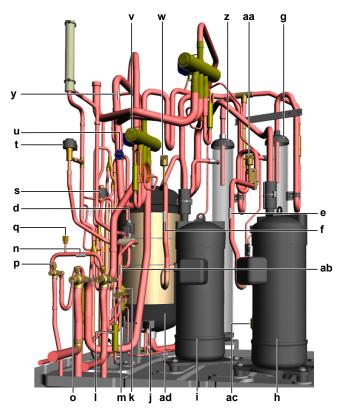
### 6.4.5 Component overview: RYMQ14~16U units

- a Switchbox, for details see "6.5 Switchbox overview" [▶ 381].
- **b** Fan motor M1F
- c Fan motor M2F
- d Liquid cooling expansion valve Y3E
- e Compressor (M1C) discharge thermistor R21T
- f Compressor (M2C) discharge thermistor R22T
- **g** Oil separator
- h Compressor M1C + body thermistor R8T
- i Compressor M2C + body thermistor R9T
- j Oil return valve Y2S
- **k** Filter
- I Filter
- **m** Charge port
- n Liquid pipe thermistor, outdoor heat exchanger R4T
- o Gas stop valve
- p Liquid stop valve
- **q** Service port
- r Gas pipe thermistor, sub-cool heat exchanger R6T
- s Sub-cool expansion Valve Y2E

- t Main expansion valve Y1E
- **u** Low pressure sensor S1NPL
- v 4-way valve Y1S
- w High pressure switch S2PH
- x Refrigerant high pressure sensor S1NPH
- y Accumulator inlet thermistor R3T
- **z** Oil separator
- **aa** High pressure switch S1PH
- **ab** Liquid pipe thermistor, sub-cool heat exchanger R5T
- ac Filter
- **ad** Accumulator
- ae Heat exchanger
- **af** De-icer thermistor, outdoor heat exchanger R7T
- **ag** Filter
- **ah** Oil return valve Y3S
- **ai** Filter
- aj Oil return valve Y4S
- ak 4-way valve Y5S

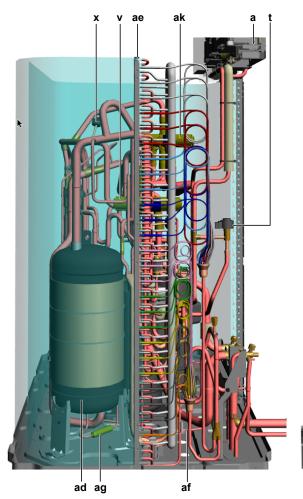
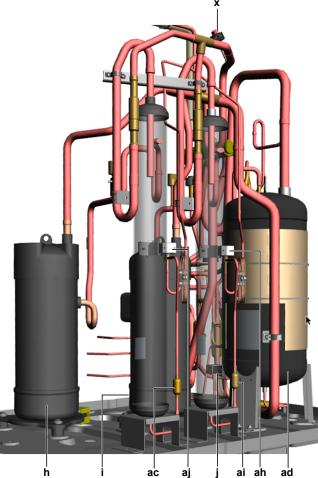
- a Switchbox, for details see "6.5 Switchbox overview" [▶ 381].
- Fan motor M1F
- c Fan motor M2F
- d Liquid cooling expansion valve Y3E
- e Compressor (M1C) discharge thermistor R21T
- Compressor (M2C) discharge thermistor R22T
- **g** Oil separator
- h Compressor M1C + body thermistor R8T
- i Compressor M2C + body thermistor R9T
- Oil return valve Y2S j
- **k** Filter
- I Filter
- m Charge port
- **n** Liquid pipe thermistor, outdoor heat exchanger R4T
- o Gas stop valve
- **p** Liquid stop valve
- **q** Service port
- Gas pipe thermistor, sub-cool heat exchanger R6T
- s Sub-cool expansion Valve Y2E

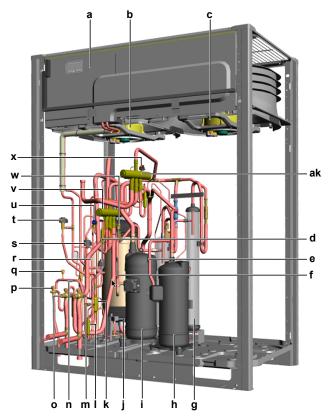
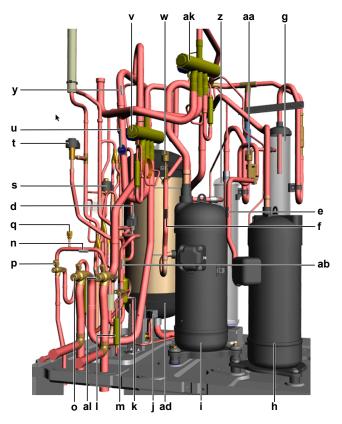
### 6.4.6 Component overview: RYMQ18~20U units

- a Switchbox, for details see "6.5 Switchbox overview" [▶ 381].
- **b** Fan motor M1F
- c Fan motor M2F
- **d** Liquid cooling expansion valve Y3E
- e Compressor (M1C) discharge thermistor R21T)
- f Compressor (M2C) discharge thermistor R22T)
- **g** Oil separator
- **h** Compressor M1C + body thermistor R8T
- i Compressor M2C + body thermistor R9T
- i Oil return valve Y2S
- **k** Filter
- I Filter
- **m** Charge port
- **n** Liquid pipe thermistor, outdoor heat exchanger R4T
- o Gas stop valve
- **p** Liquid stop valve
- **q** Service port
- r Gas pipe thermistor, sub-cool heat exchanger R6T
- s Sub-cool expansion Valve Y2E

- t Main expansion valve Y1E
- u Low pressure sensor S1NPL
- v 4-way valve Y1S
- w High pressure switch S2PH
- x Refrigerant high pressure sensor S1NPH
- y Accumulator inlet thermistor R3T
- **z** Oil separator
- **aa** High pressure switch S1PH
- **ab** Liquid pipe thermistor, sub-cool heat exchanger R5T
- ac Filter
- **ad** Accumulator
- ae Heat exchanger
- **af** De-icer thermistor, outdoor heat exchanger R7T
- **ag** Filter
- **ah** Oil return valve Y3S
- **ai** Filter
- **aj** Oil return valve Y4S
- ak 4-way valve Y5S
- al Equalisation pipe

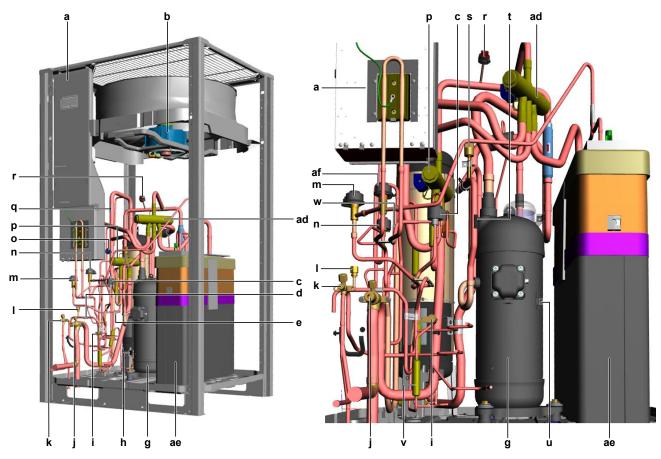
### 6.4.7 Component overview: RYYQ8~12U units

- a Switchbox, for details see "6.5 Switchbox overview" [▶ 381].
- **b** Fan motor
- c Liquid cooling expansion valve Y3E
- **d** Liquid pipe thermistor, outdoor heat exchanger R4T
- e Liquid pipe thermistor, sub-cool heat exchanger R5T
- Oil separator
- **g** Compressor M1C
- **h** Oil return valve Y2S
- i Charge port
- j Gas stop valve
- **k** Liquid stop valve
- I Service port
- m Main expansion valve Y1E
- n Sub-cool expansion Valve Y2E
- o Low pressure sensor S1NPL
- **p** 4-way valve Y1S

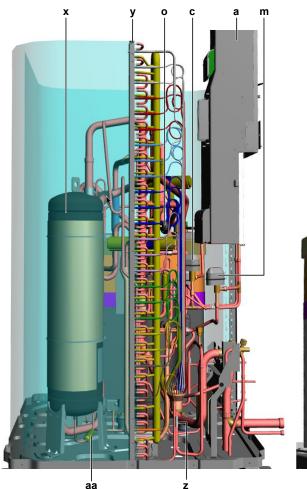
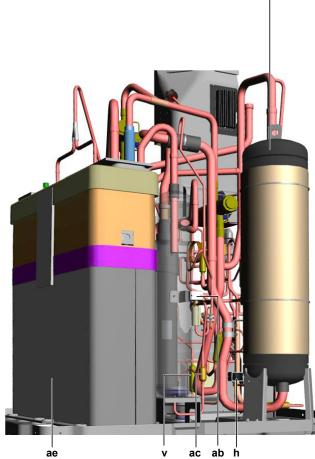
- a Switchbox, for details see "6.5 Switchbox overview" [▶ 381].
- Fan motor
- Liquid cooling expansion valve Y3E
- Liquid pipe thermistor, outdoor heat exchanger R4T
- Liquid pipe thermistor, sub-cool heat exchanger R5T
- Oil separator
- **g** Compressor M1C
- Oil return valve Y2S
- Charge port i
- j Gas stop valve
- k Liquid stop valve
- 1 Service port
- m Main expansion valve Y1E
- n Sub-cool expansion Valve Y2E
- o Low pressure sensor S1NPL
- **p** 4-way valve Y1S

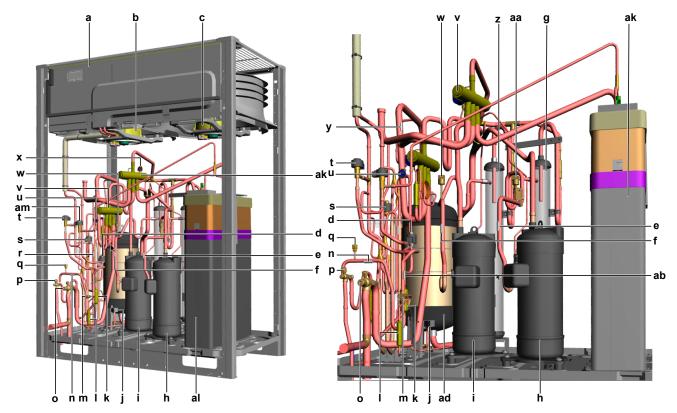
- a Switchbox, for details see "6.5 Switchbox overview" [▶ 381].
- **b** Fan motor M1F
- c Fan motor M2F
- **d** Liquid cooling expansion valve Y3E
- e Compressor (M1C) discharge thermistor R21T
- f Compressor (M2C) discharge thermistor R22T
- **g** Oil separator
- **h** Compressor M1C + body thermistor R8T
- i Compressor M2C + body thermistor R9T
- j Oil return valve Y2S
- **k** Filter
- I Filter
- **m** Charge port
- **n** Liquid pipe thermistor, outdoor heat exchanger R4T
- Gas stop valve
- **p** Liquid stop valve
- **q** Service port
- r Gas pipe thermistor, sub-cool heat exchanger R6T
- **s** Sub-cool expansion Valve Y2E
- t Main expansion valve Y1E

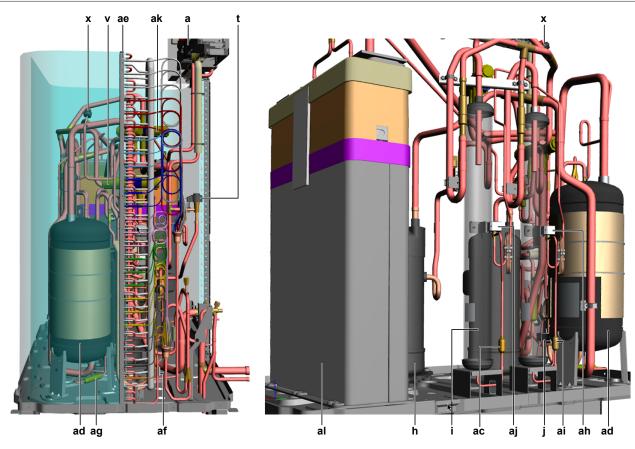
- **a** Switchbox, for details see "6.5 Switchbox overview" [▶ 381].
- Fan motor M1F
- c Fan motor M2F
- d Liquid cooling expansion valve Y3E
- e Compressor (M1C) discharge thermistor R21T
- Compressor (M2C) discharge thermistor R22T
- Oil separator
- **h** Compressor M1C + body thermistor R8T
- i Compressor M2C + body thermistor R9T
- Oil return valve Y2S j
- Filter
- I Filter
- m Charge port
- **n** Liquid pipe thermistor, outdoor heat exchanger R4T
- o Gas stop valve
- Liquid stop valve
- **q** Service port
- Gas pipe thermistor, sub-cool heat exchanger R6T
- Sub-cool expansion Valve Y2E
- t Main expansion valve Y1E

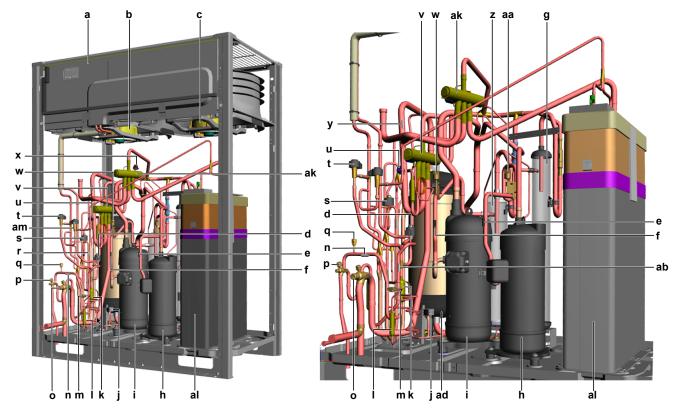
- a Switchbox, for details see "6.5 Switchbox overview" [▶ 381].
- **b** Fan motor M1F
- c Fan motor M2F
- d Liquid cooling expansion valve Y3E
- e Compressor (M1C) discharge thermistor R21T
- f Compressor (M2C) discharge thermistor R22T
- **g** Oil separator
- **h** Compressor M1C + body thermistor R8T
- i Compressor M2C + body thermistor R9T
- j Oil return valve Y2S
- **k** Filter
- I Filter
- **m** Charge port
- **n** Liquid pipe thermistor, outdoor heat exchanger R4T
- Gas stop valve
- **p** Liquid stop valve
- **q** Service port
- r Gas pipe thermistor, sub-cool heat exchanger R6T
- s Sub-cool expansion Valve Y2E
- t Main expansion valve Y1E

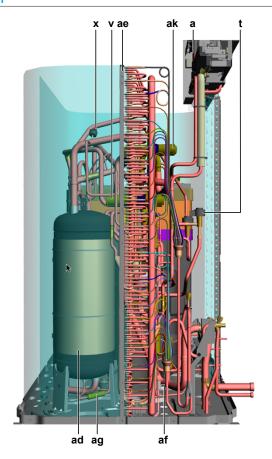
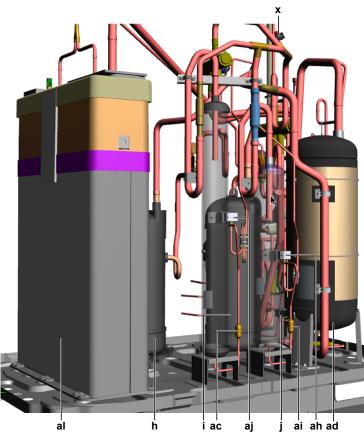
- **a** Switchbox, for details see "6.5 Switchbox overview" [▶ 381].
- Fan motor M1F
- c Fan motor M2F
- d Liquid cooling expansion valve Y3E
- Compressor (M1C) discharge thermistor R21T
- **f** Compressor (M2C) discharge thermistor R22T
- **g** Oil separator
- **h** Compressor M1C + body thermistor R8T
- Compressor M2C + body thermistor R9T
- Oil return valve Y2S j
- **k** Filter
- Filter
- m Charge port
- n Liquid pipe thermistor, outdoor heat exchanger R4T
- o Gas stop valve
- **p** Liquid stop valve
- **q** Service port
- Gas pipe thermistor, sub-cool heat exchanger R6T
- Sub-cool expansion Valve Y2E
- t Main expansion valve Y1E
